TECHNOLOGY INSERTION-ENGINEERING SERVICES
PROCESS CHARACTERIZATION
TASK ORDER NO. 1

VOLUME III
OC-ALC
BOOK 1 OF 2

CONTRACT SUMMARY REPORT AND QUICK FIX PLAN

15 DECEMBER 1989

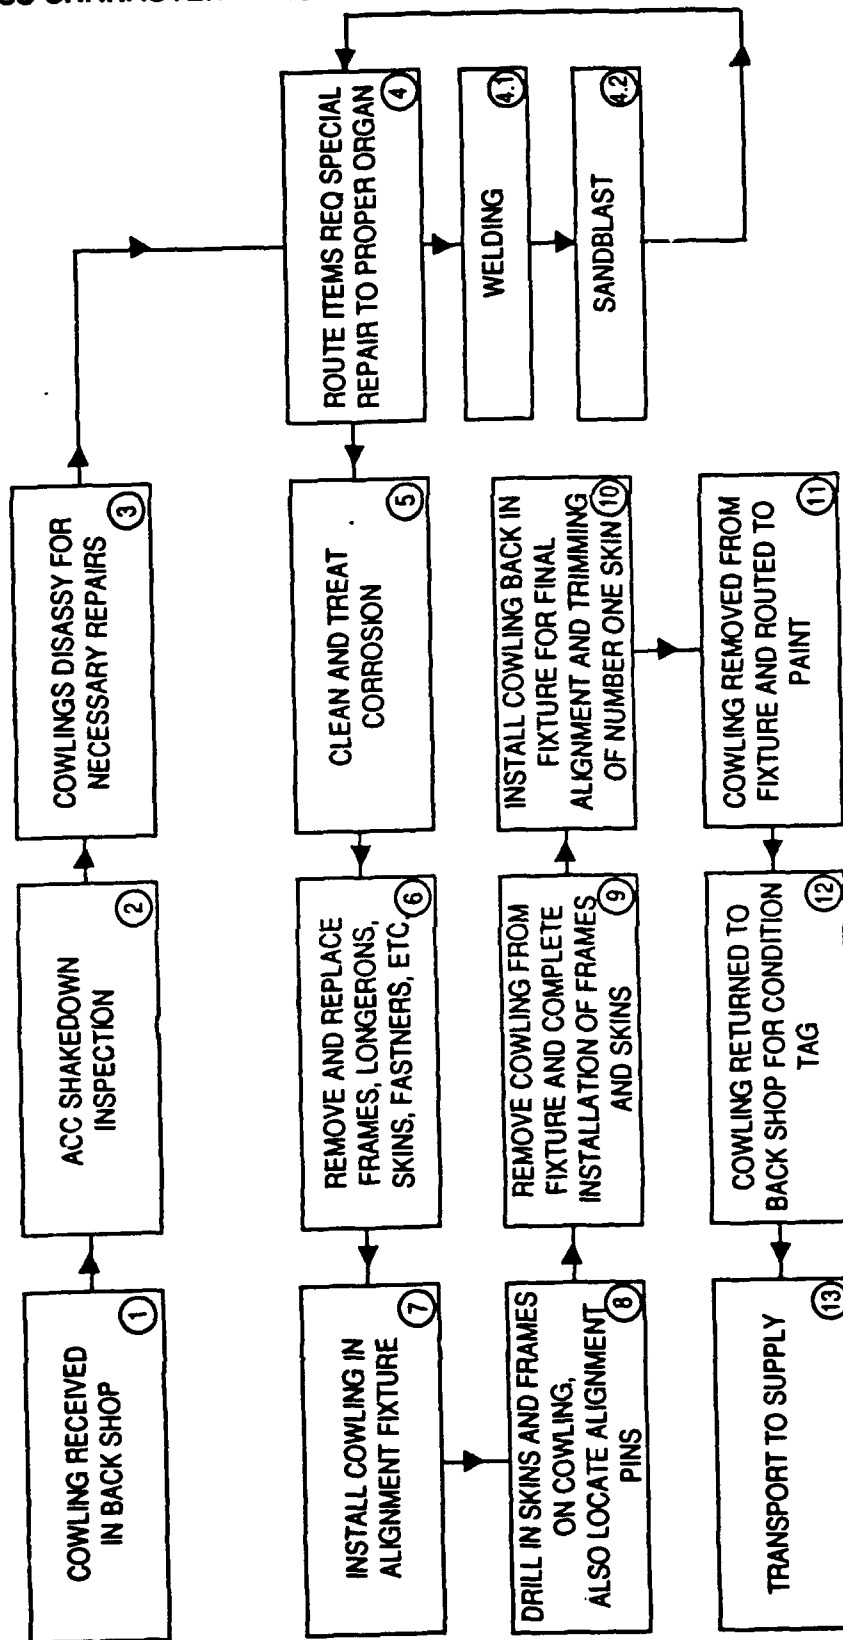
LSC-20218A

**FLOW CHART SIDE COWL REPAIR SHOP
FIGURE 6.1-2**

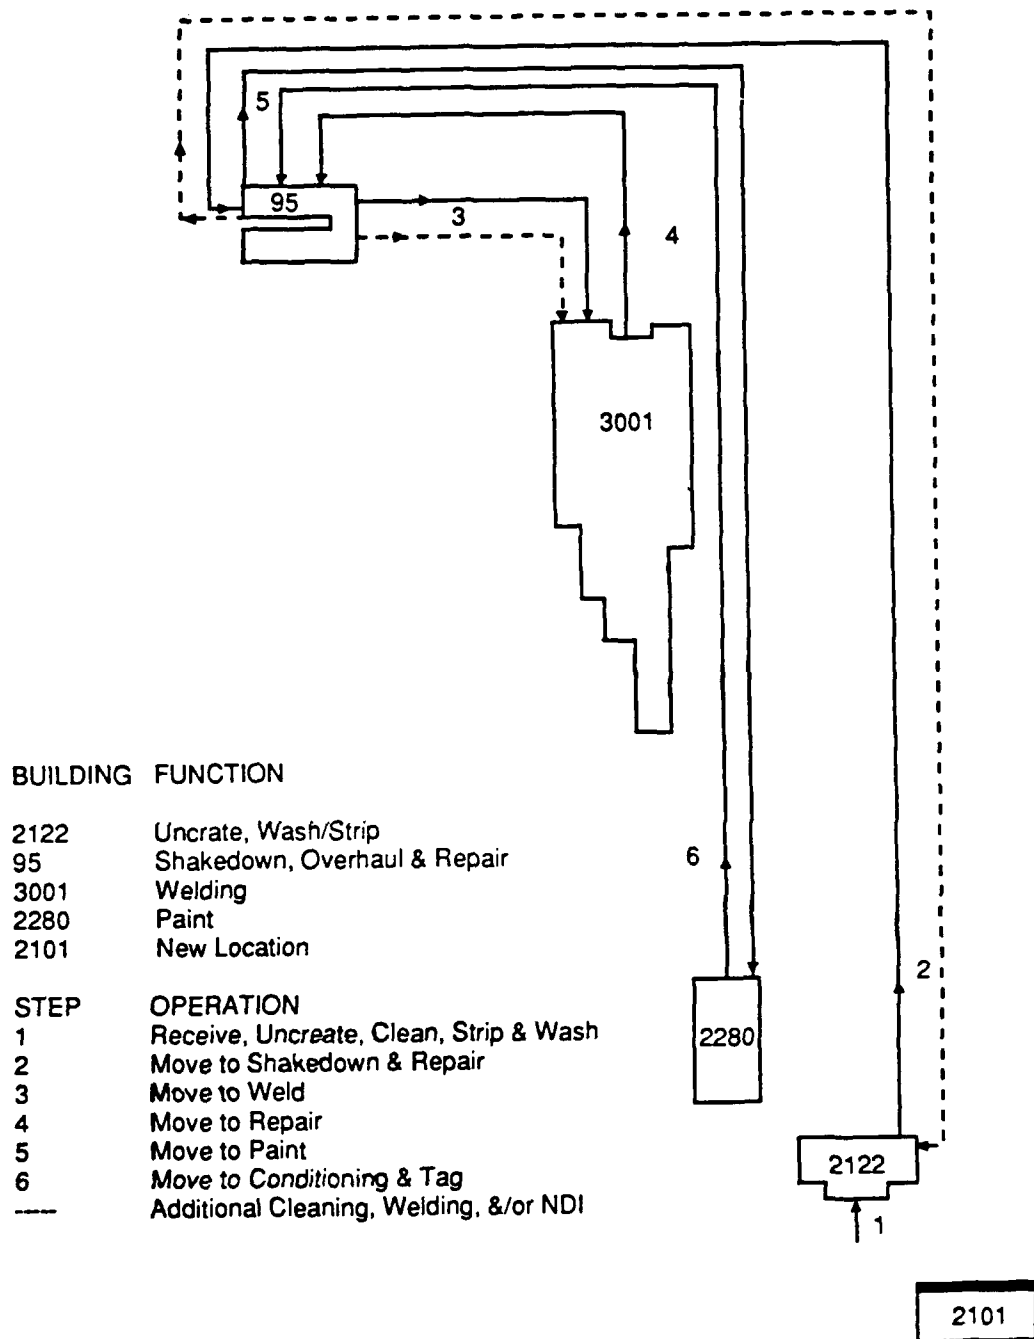
LSC-20232

The first operation to be done is a visual shakedown inspection to determine the amount of work required. If welding is required, the end item is moved to MATPIW in Building 3001 (see Step 3, Figure 6.1.1-1). The welding operation could take from three to six days. After welding, it is returned to MABPAB to continue the repair process (see Step 4, Figure 6.1.1-1). The sheet metal repair process may vary, depending upon the size of the end item, and the number and size of damaged parts (longerons, ribs, clips, angles, etc.).

**BASIC SHEET METAL REPAIR FLOW
FIGURE 6.1.1-1**

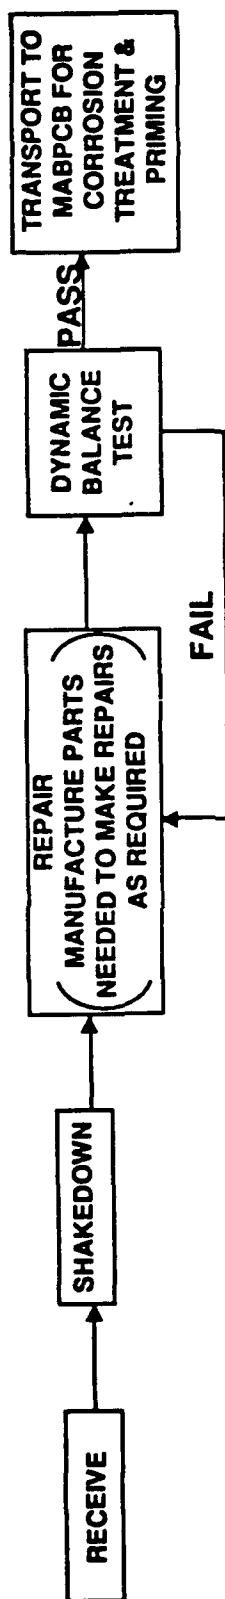
LSC-20438

**PROCESS FLOW FOR FLIGHT CONTROLS
(GOVERNORS, RUDDERS)
FIGURE 6.2.1-1**

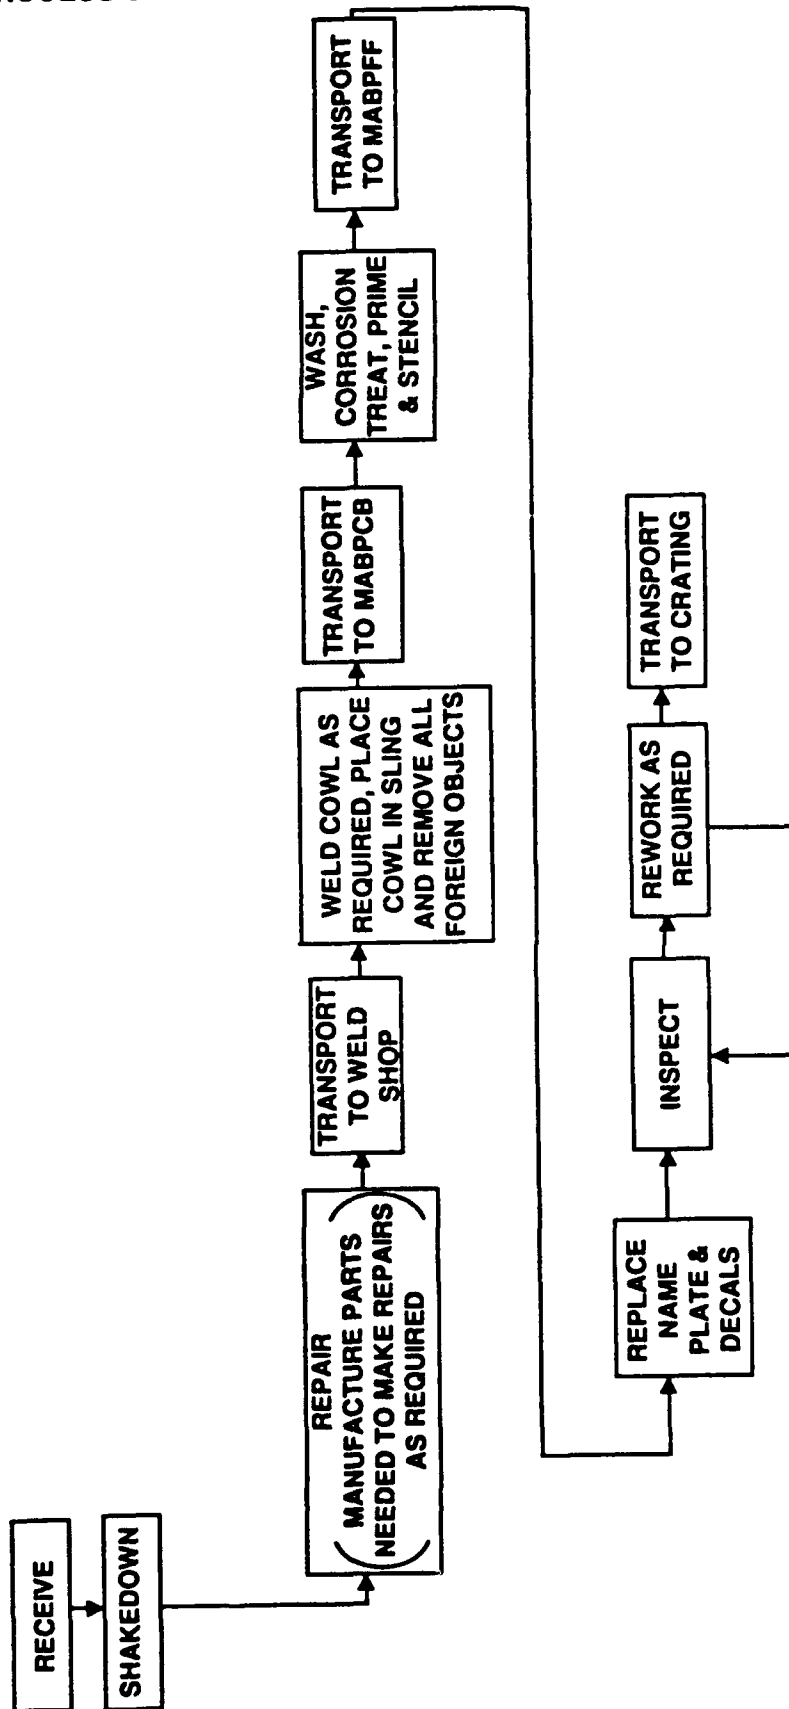
LSC-20434

**PROCESS FLOW FOR ENGINE NOSE COWL
FIGURE 6.2.1-2**

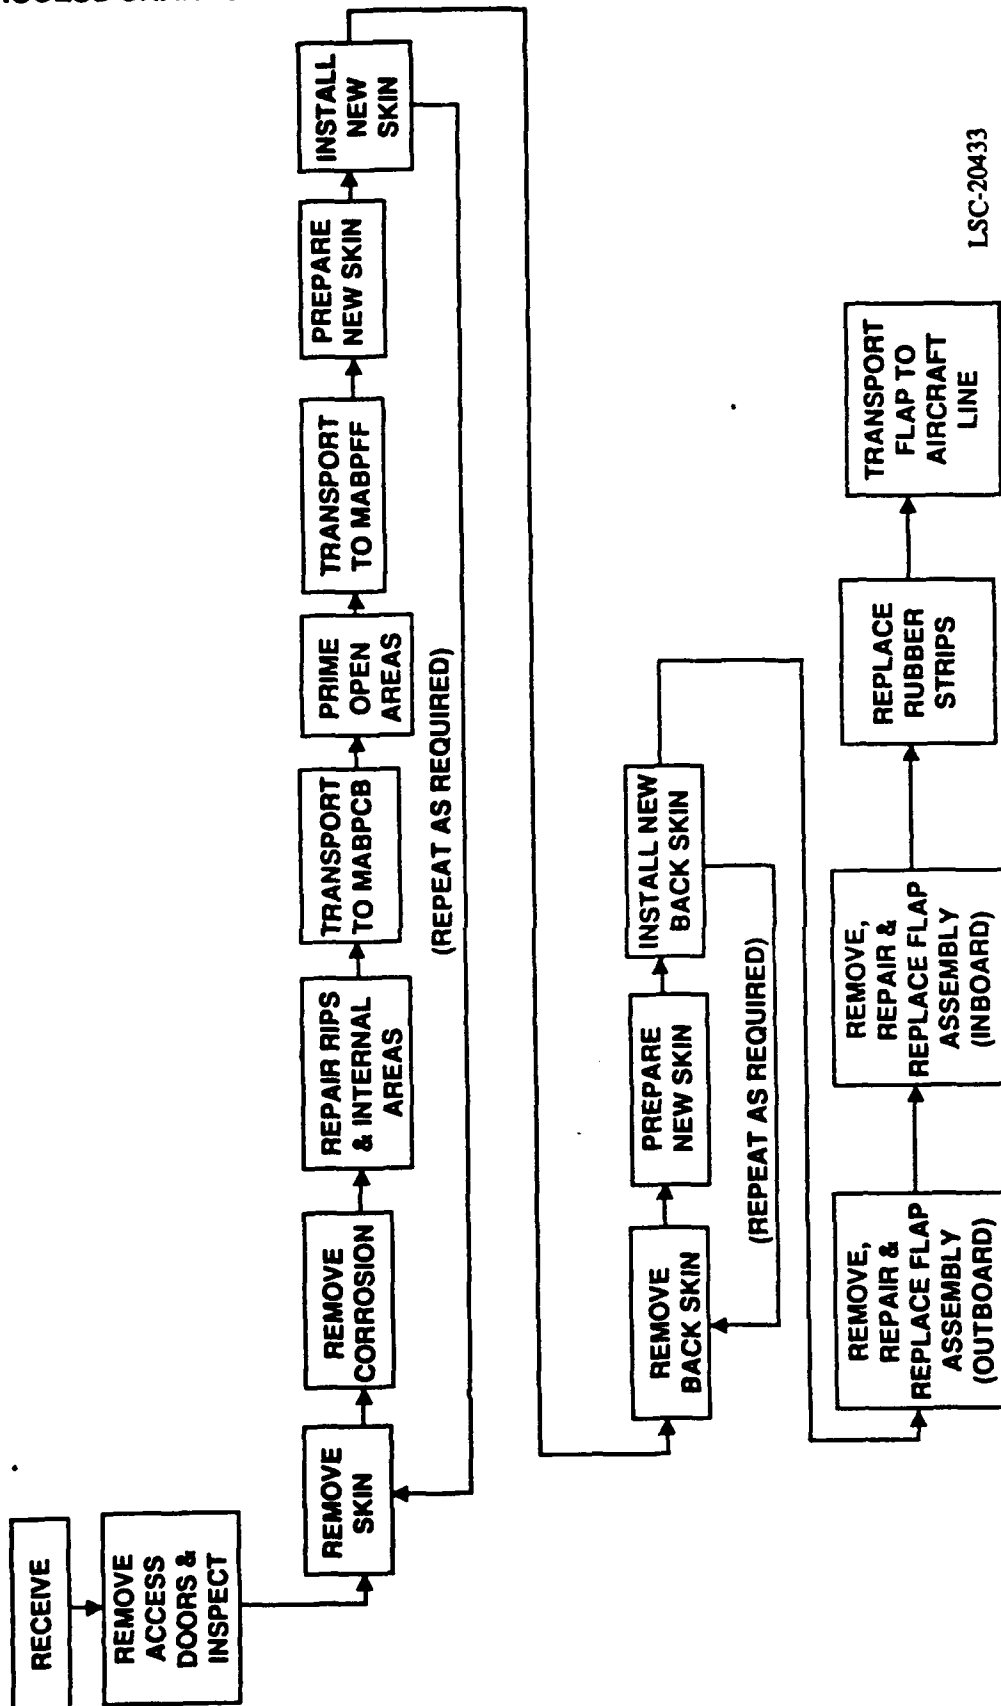
LSC-20433

PROCESS FLOW FOR WING FLAPS
FIGURE 6.2.1-3

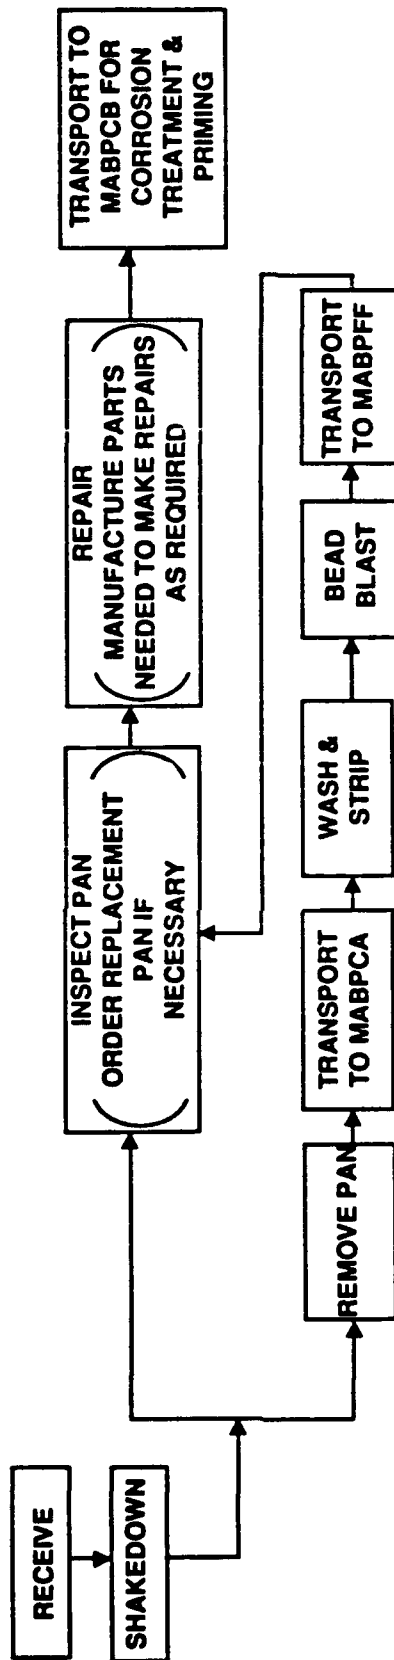
LSC-20437

**PROCESS FLOW FOR ESCAPE HATCH
FIGURE 6.2.1-4**

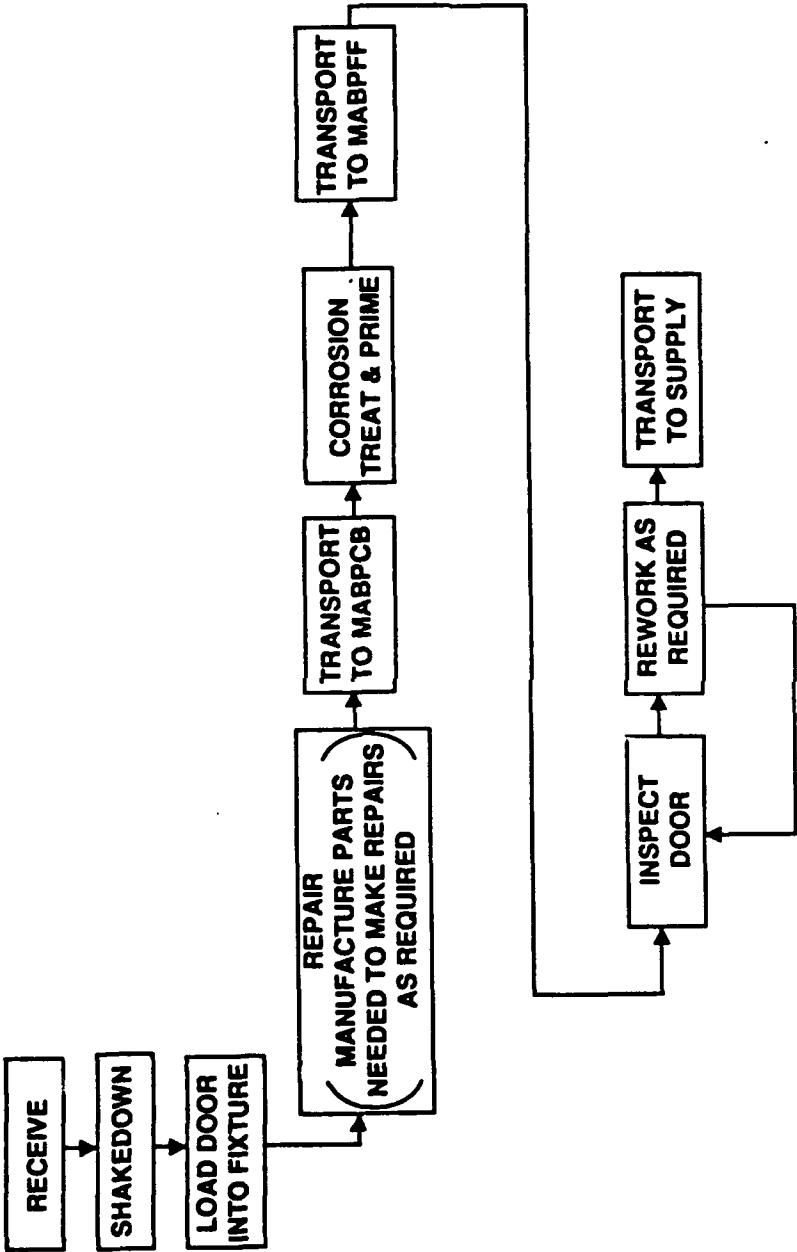
LSC-20435

PROCESS FLOW FOR BOMB BAY DOORS
FIGURE 6.2.1-5

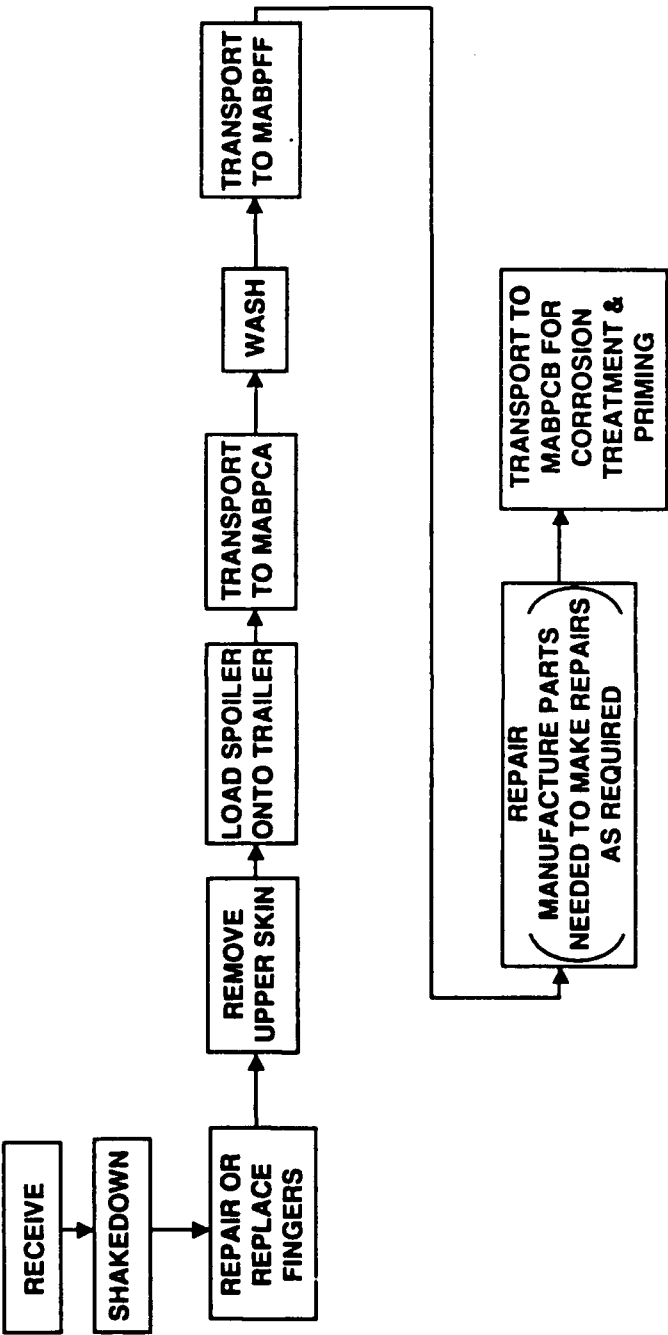
LSC-20436

PROCESS FLOW FOR SPOILERS
FIGURE 6.2.1-6

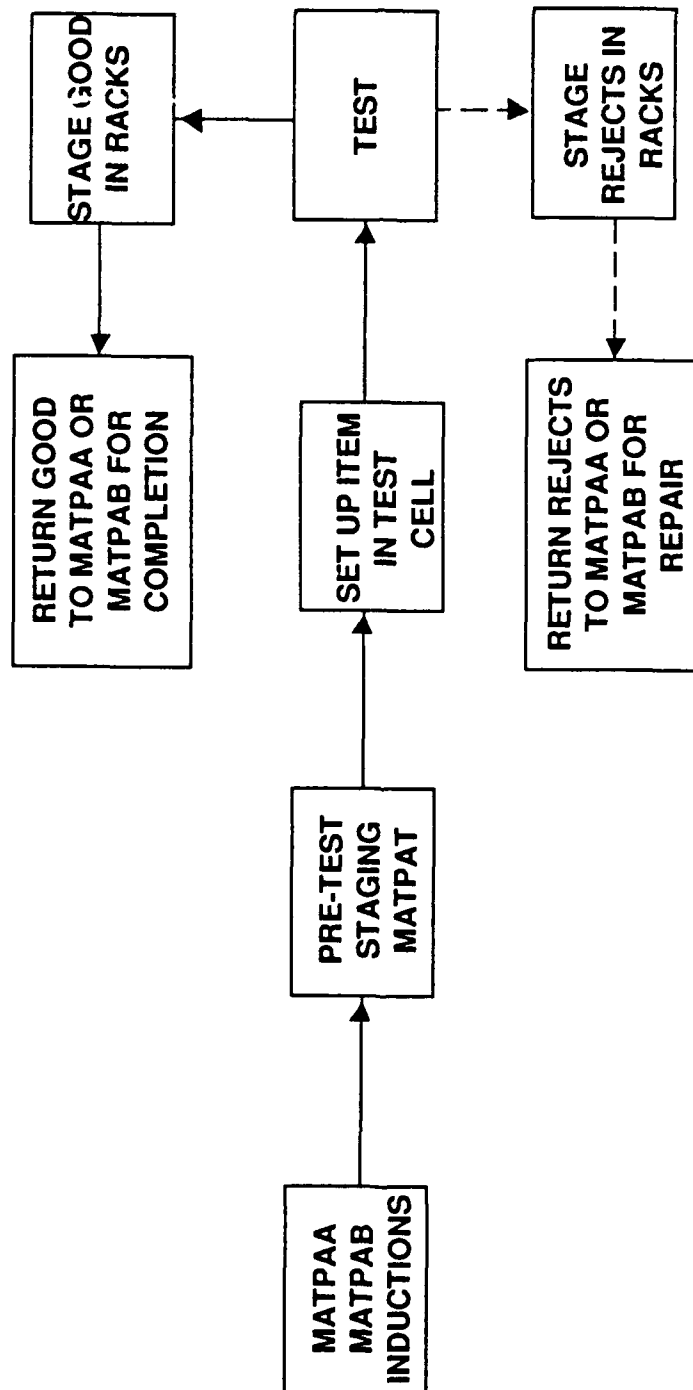
1.5C-20396A

- Regulators - Apply set flow (up & down stream pressure)
- Valves - Set pressure to provide proper flow
- Turbine - Air flow-check cooling efficiency
- Drives - Electric & hydraulic load banks to apply drive loads to assure alternator operation

GENERIC FLOW PROCESS CHART — MATPAT - ALL TESTED ITEMS
FIGURE 6.5.1-1

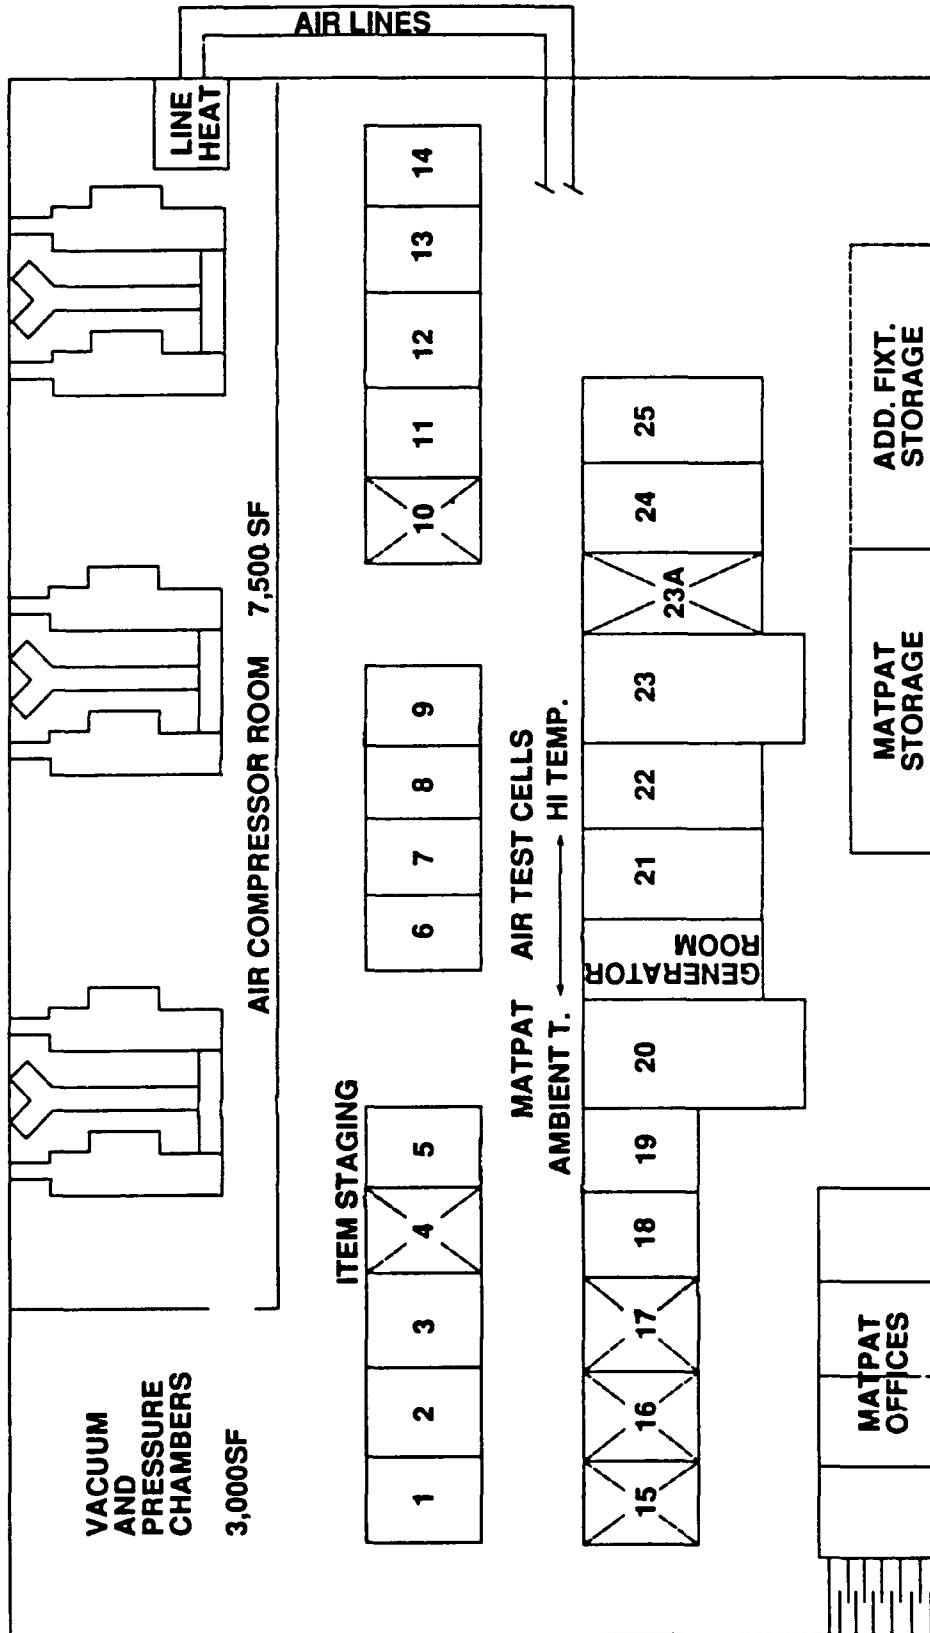
LSC-20397

- Provide inexpensive jib crane to handle heavy fixtures.

MATPAT LAYOUT REVISIONS
FIGURE 6.5.1-2

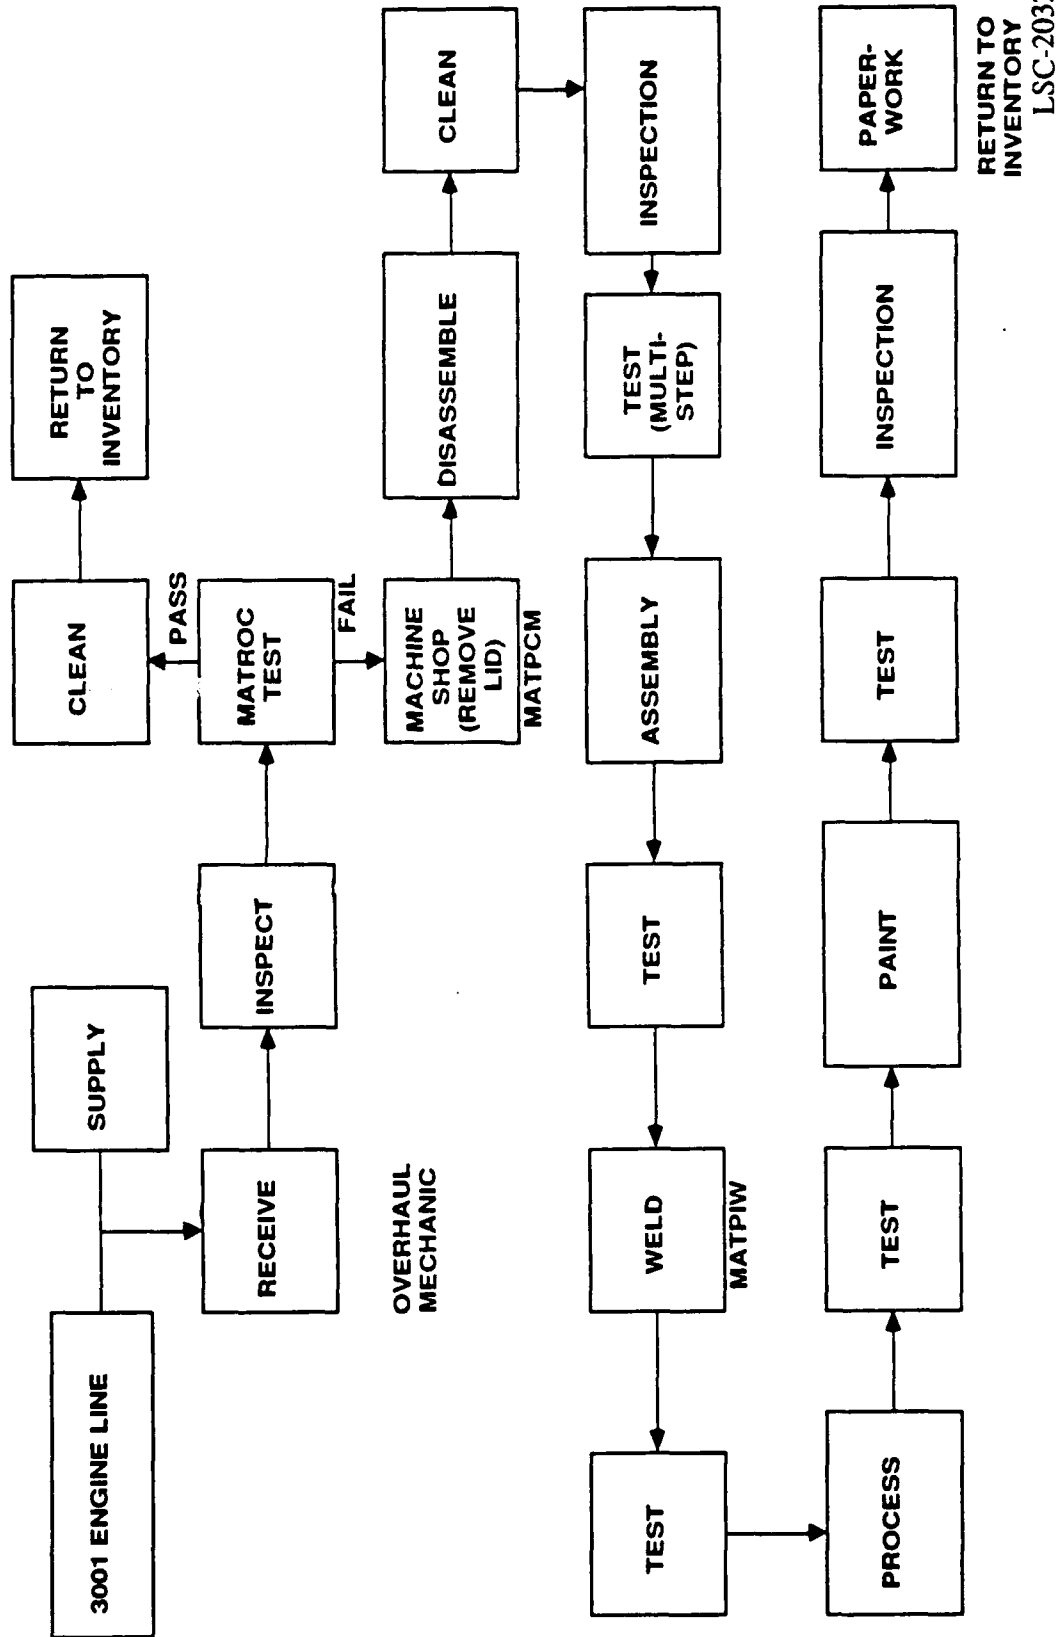
LSC-20325

FLOW DIAGRAM FOR OVERHAUL OF IGNITERS (MATPCA)

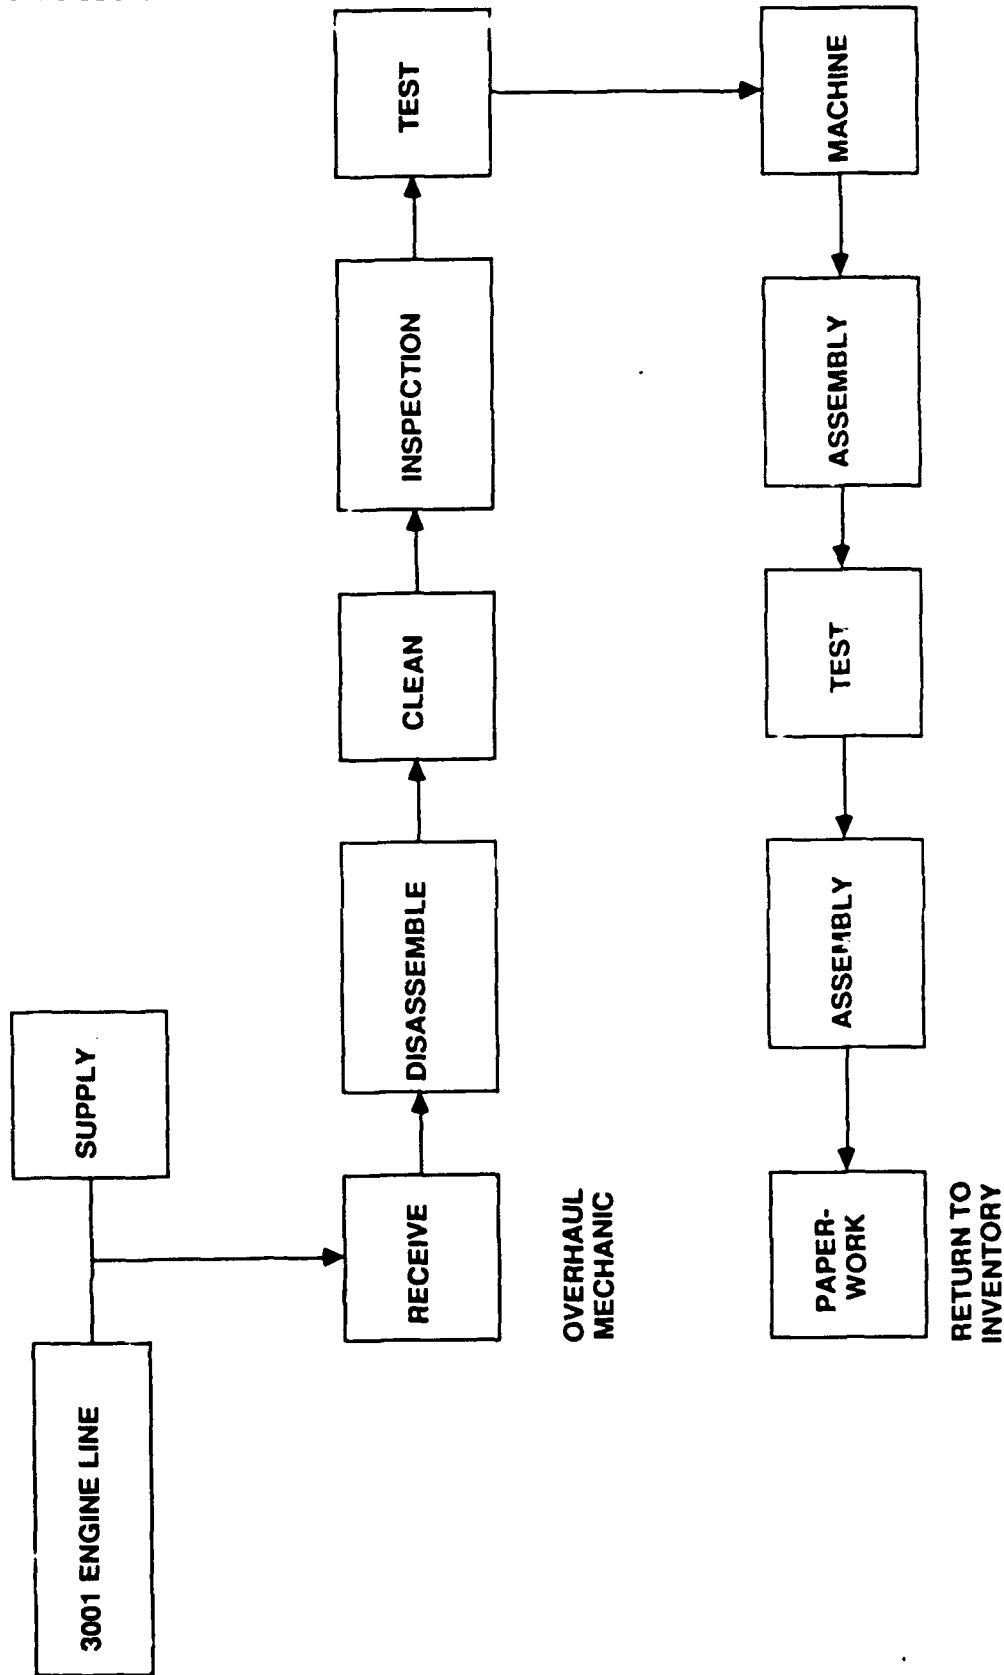
LSC-20333

FLOW DIAGRAM OF ELECTROMAG 3-WAY SELECT VALVES (MATPCA)
FIGURE 6.6.1-2

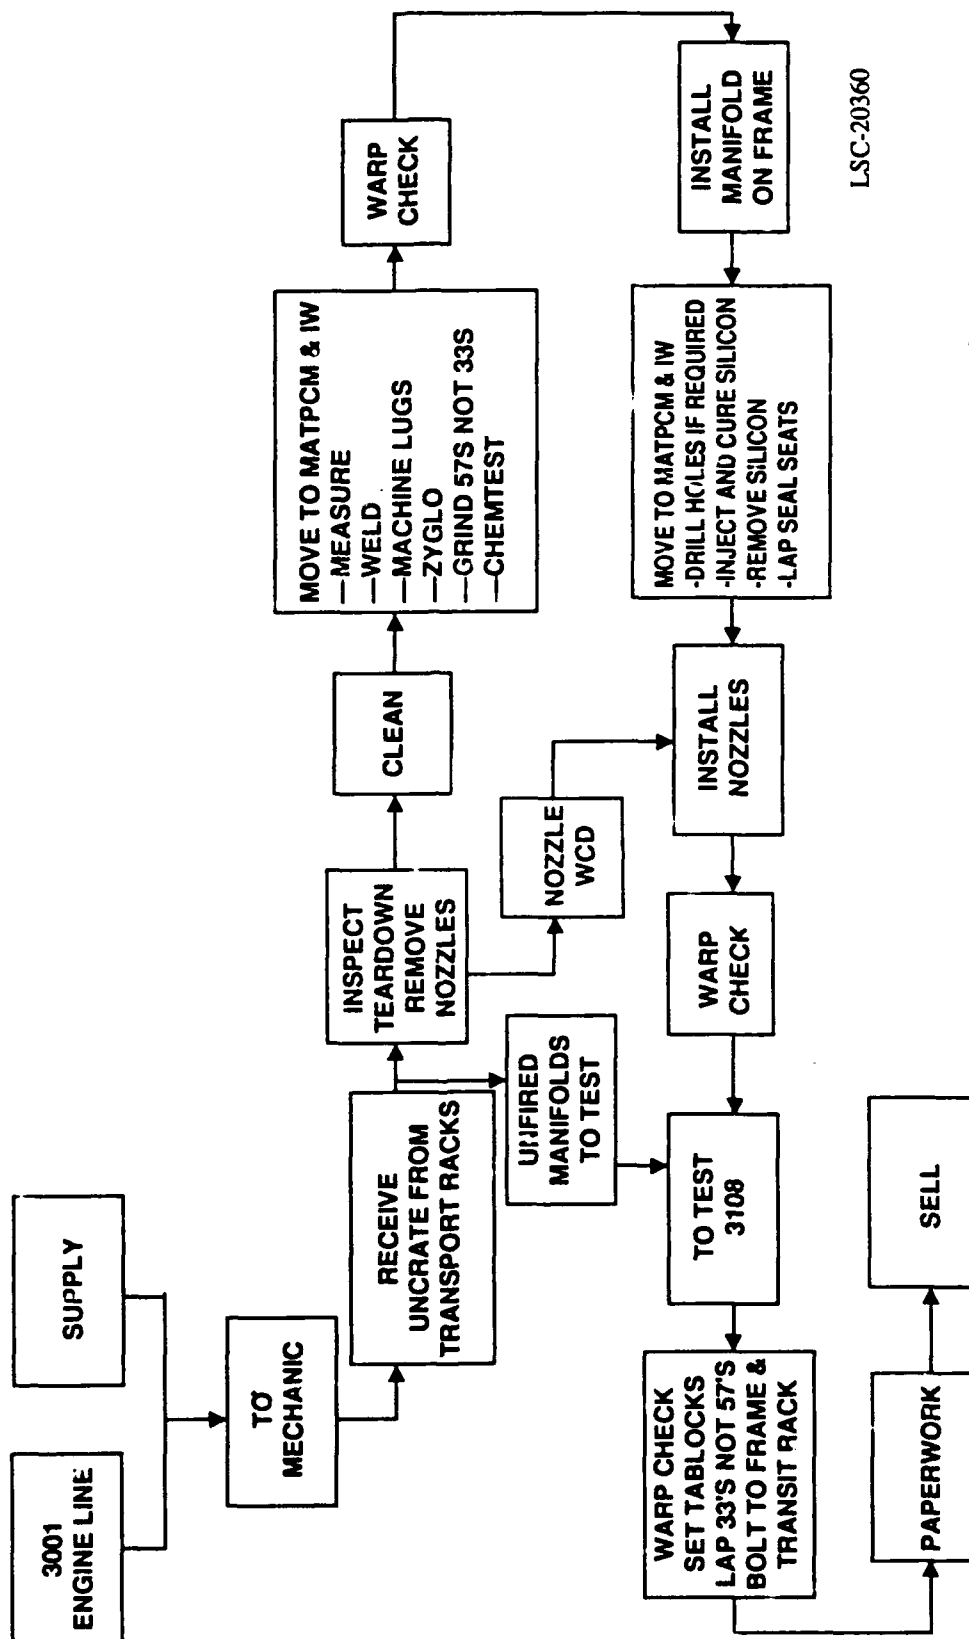
LSC-20360

MATPCB MANIFOLDS (OVERHAUL) PROCESS CHART

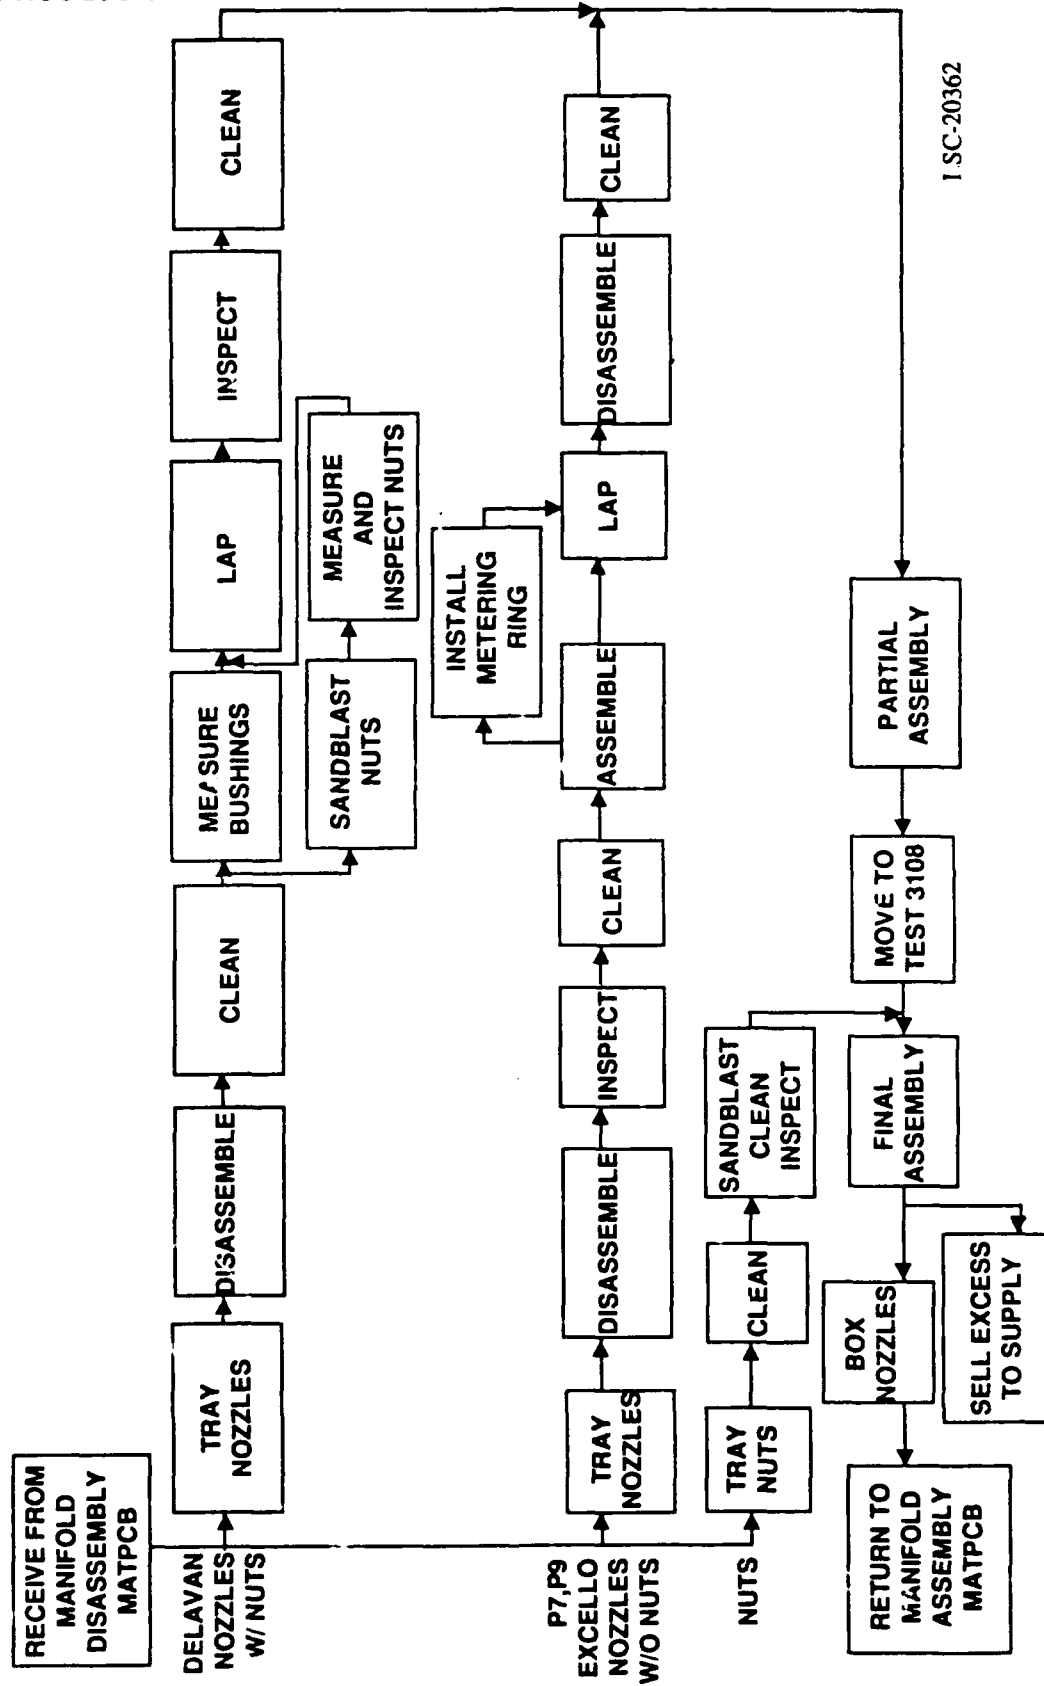
1 SC-20362

MATPCB NOZZLES (OVERHAUL) PROCESS CHART

The fuel nozzle overhaul area is the smallest of the MATPCB areas. The general process flow for nozzle overhaul is presented in Figure 6.7.1-2. It is located immediately adjacent to the manifold area providing minimal transit distance and time. The workbenches are somewhat cluttered because the area is small and close-quartered. The low-smoke nozzle overhaul area is near the manifold final assembly area. The fuel and hydraulic pump sub-unit is arranged in an east/west orientation with activities located basically in-line. Since there are many types of pumps overhauled, there is no assembly line arrangement. All overhaul activities (as shown in Figure 6.7.1-3) are performed at single workstations except for cleaning, test, and machining. Some workstations (benches) have PCN unique fixtures attached to them. These workbenches are not arranged in categories of pumps, but are scattered throughout the overhaul sub-unit area. The cleaning tanks, in which work is performed by the overhaul mechanics, are located within the overhaul area. This reduces transit time. Non Destructive Inspection (NDI) on the pumps is performed by dedicated NDI personnel within the sub-unit overhaul area. Fluorescent penetrant and fluorescent magnetic particle methods are used in this RCC for NDI of parts.

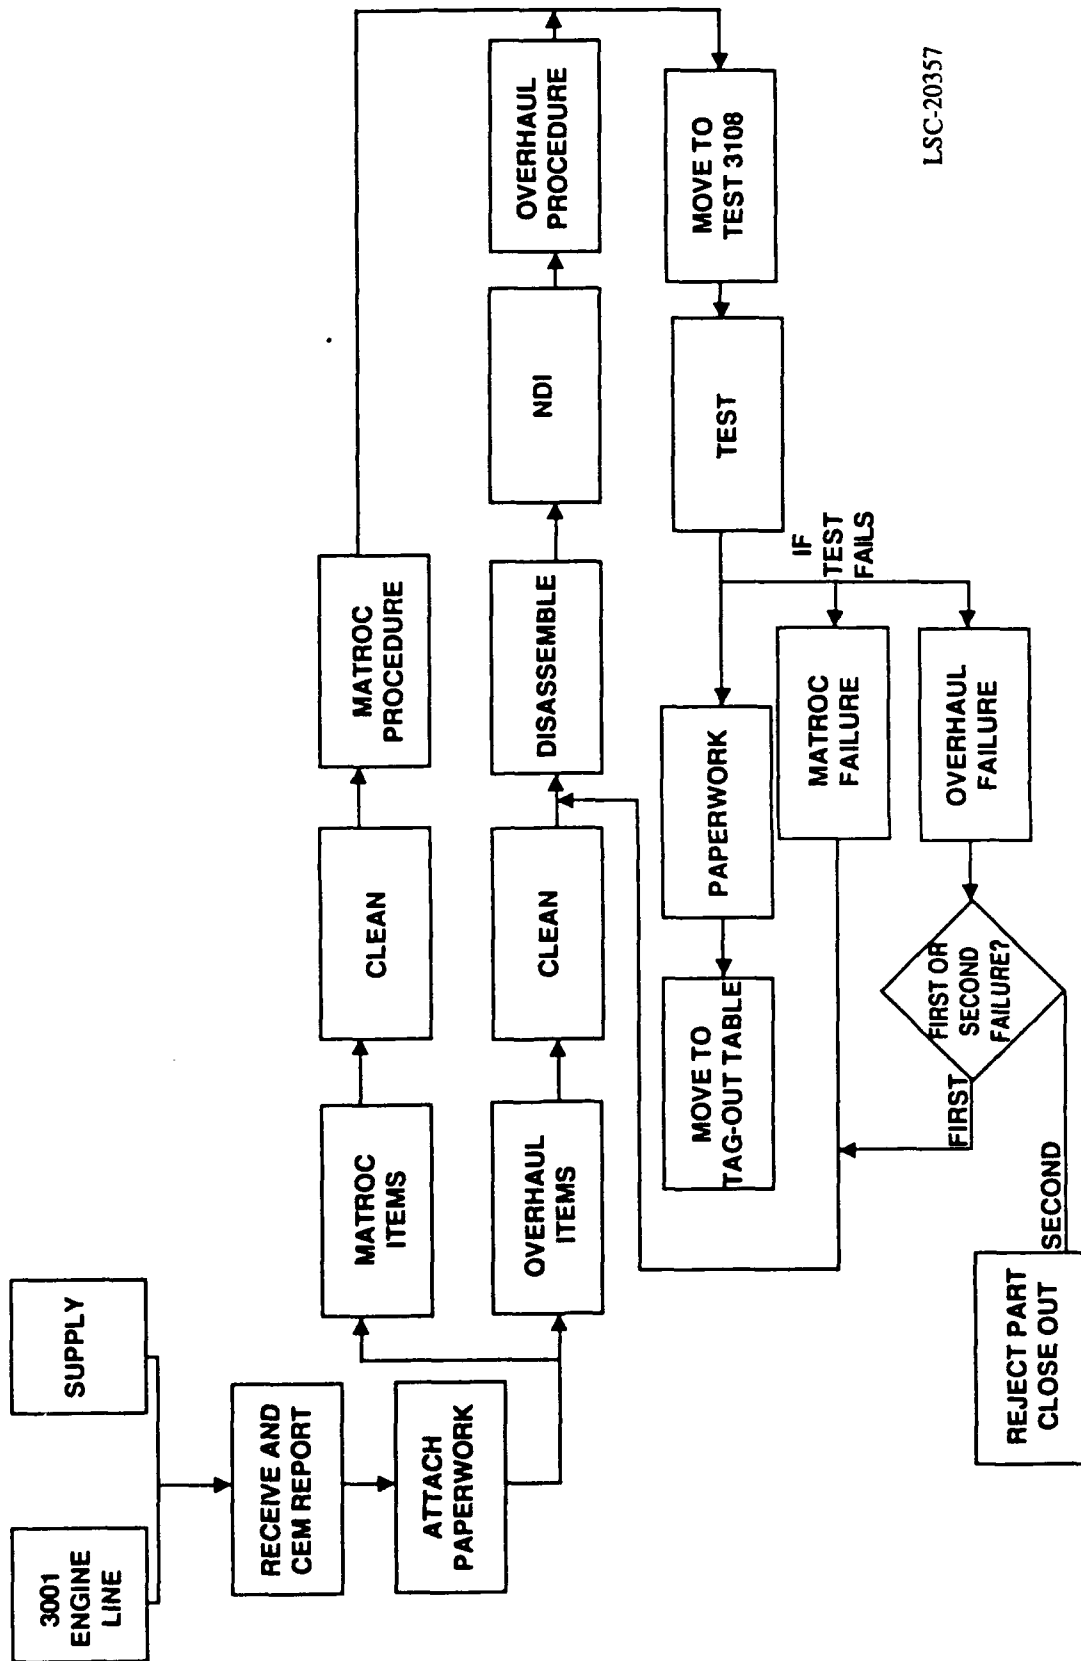
LSC-20357

MATPCB PUMP (OVERHAUL) PROCESS CHART
FIGURE 6.7.1-3

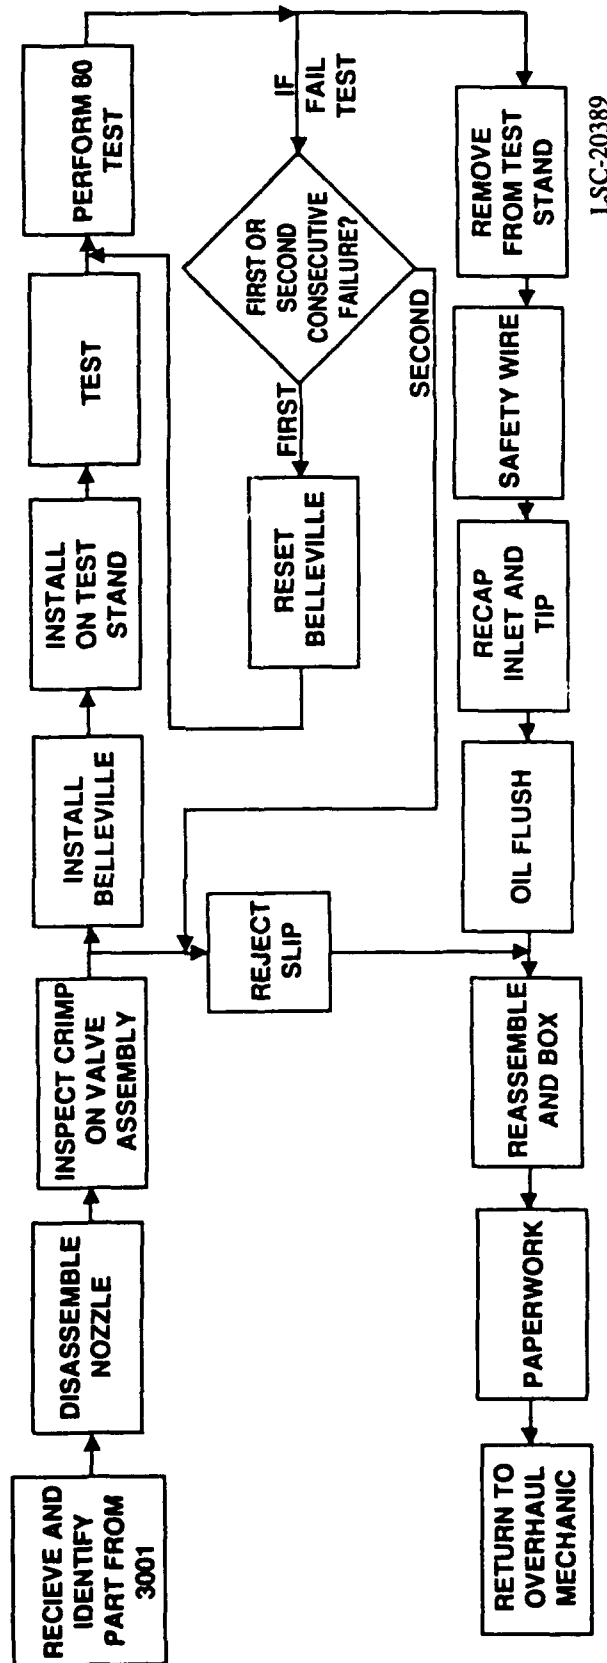
MATPCB NOZZLE (TEST) PROCESS CHART

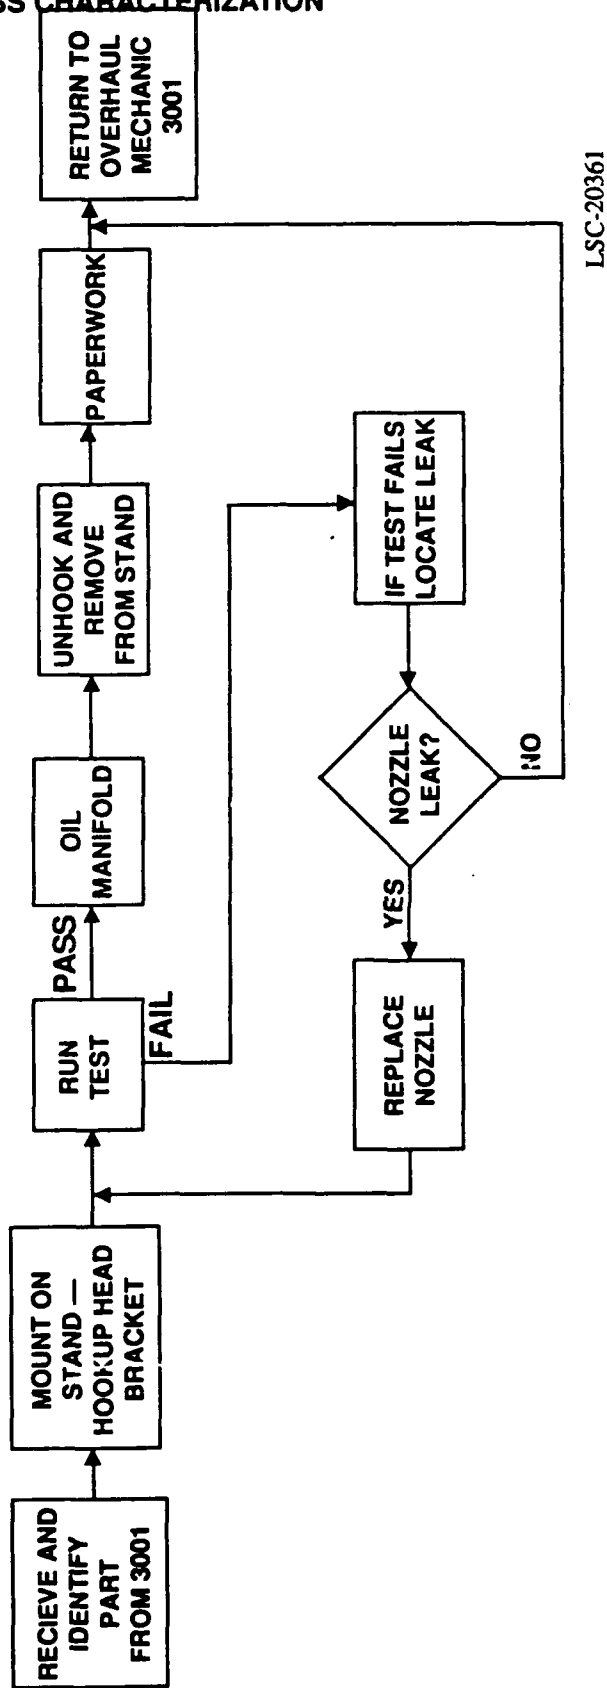
MATPCB MANIFOLDS (TEST) PROCESS CHART
FIGURE 6.7.1-5
